The Secretary
of the Interior's
Standards for
Rehabilitation &

Illustrated
Guidelines
for
Rehabilitating
Historic
Buildings

U.S. Department of the Interior
National Park Service
Cultural Resources
Heritage Preservation Services

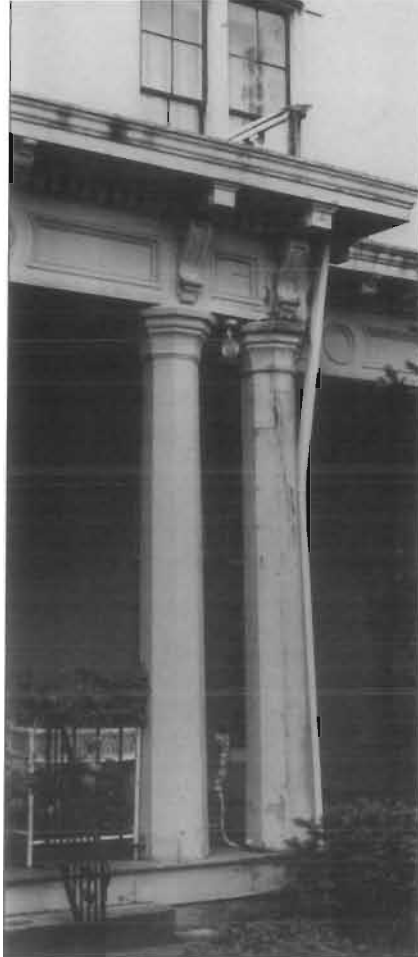
The roof drainage system has been neglected for such a long time that, as a result, the wood cornice and a porch column are both severely deteriorated.

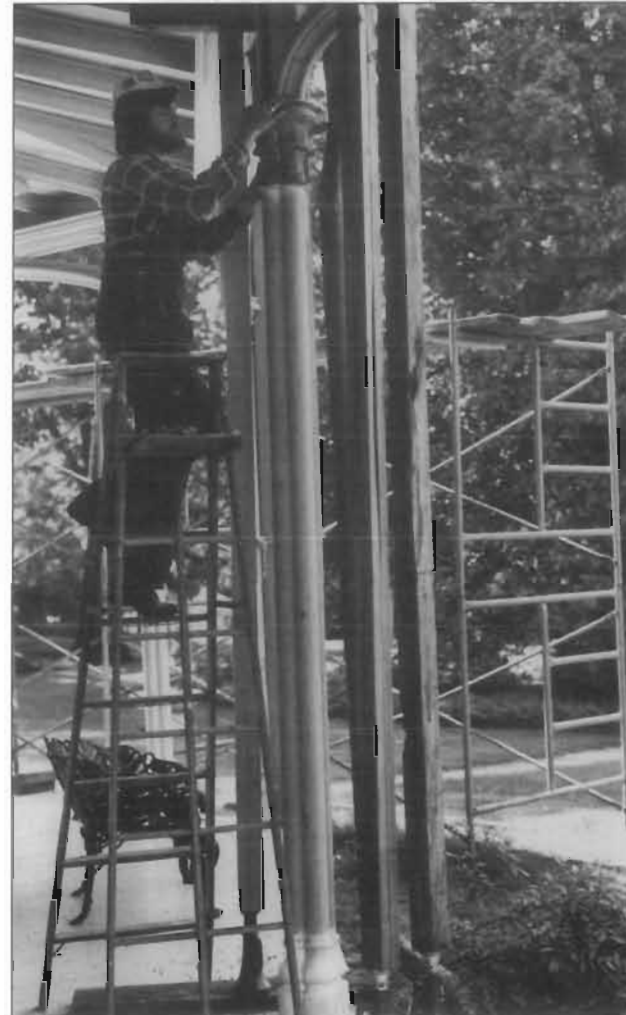
Careful inspection of porch features such as these column capitals is necessary before initiating a rehabilitation project.

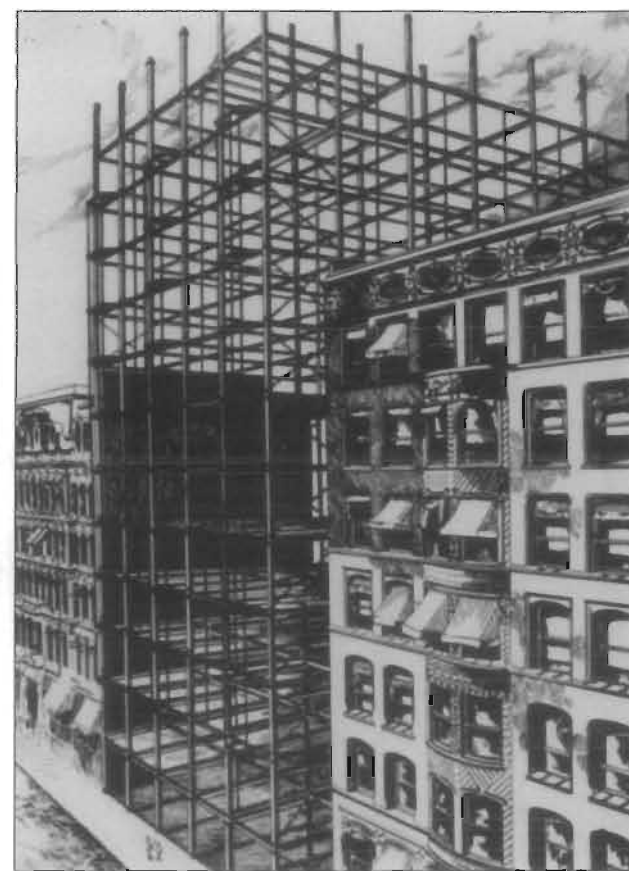
Iron and Steel Skeleton Frame, Unity Building, Chicago, Illinois, 1891-1892 (Clinton J. Warren, architect). *The development of the skeleton frame was pioneered by architects of the "Chicago School" in the late-19th century. With this method the weight of the building is carried on the frame, not the walls, allowing the construction of taller buildings without increasing the wall thickness.*
