# THE SECRETARY OF THE INTERIOR'S STANDARDS FOR REHABILITATION &

# ILLUSTRATED GUIDELINES ON SUSTAINABILITY FOR REHABILITATING HISTORIC BUILDINGS

U.S. Department of the Interior  
National Park Service  
Technical Preservation Services  
Washington, D.C.

2011

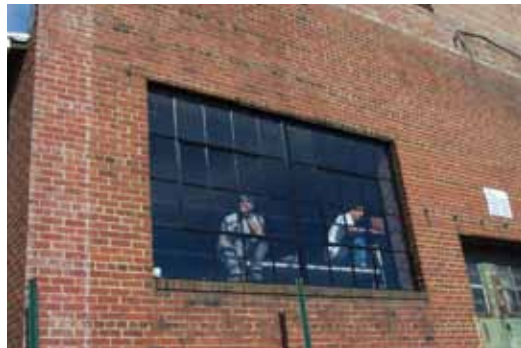
35

**Recommended:** [33-35] Original metal windows were appropriately repaired as part of the rehabilitation of this historic industrial building.

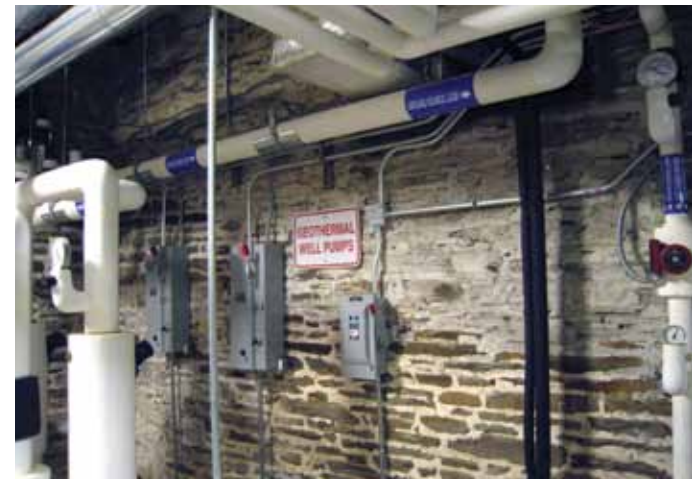
70

**Recommended:** [70-71] A geothermal system was installed on the property of this historic mansion, but only after an archeological investigation was conducted of the grounds.

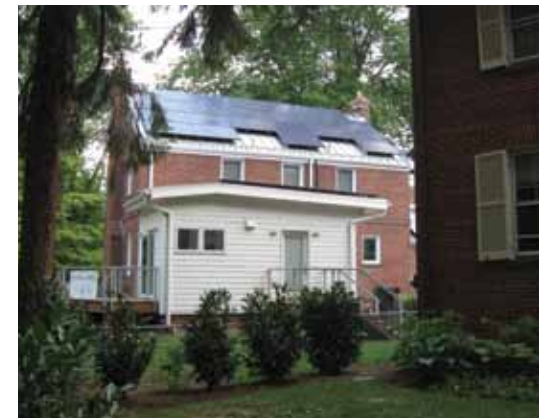
75

**Not Recommended:** [75] Solar roof panels have been installed at the rear, but because the house is situated on a corner, they are highly visible and negatively impact the character of the historic property.

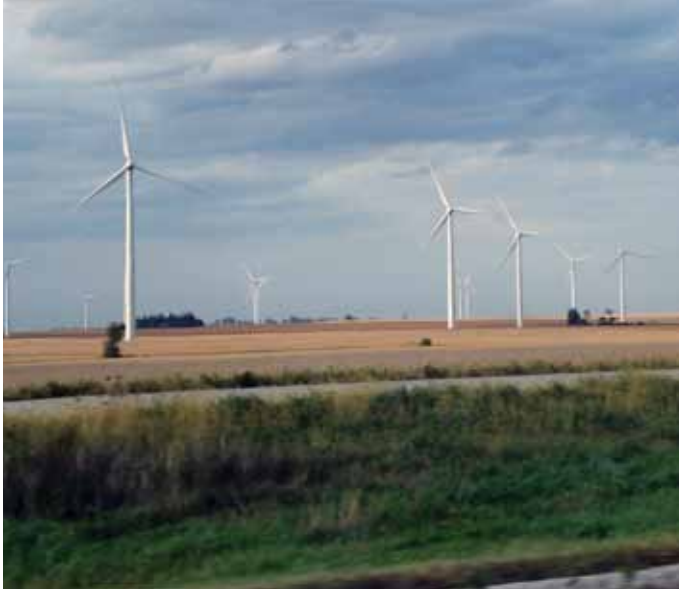
80

**Recommended:** [80] It is often best to install wind-powered equipment in off-site, rural locations to avoid negatively impacting a historic building and its site.
