THE SECRETARY
OF THE INTERIOR'S
**STANDARDS FOR
THE TREATMENT
OF HISTORIC
PROPERTIES**

WITH
**GUIDELINES FOR
PRESERVING,
REHABILITATING,
RESTORING &
RECONSTRUCTING
HISTORIC
BUILDINGS**

U.S. Department of the Interior
National Park Service
Technical Preservation Services

2017

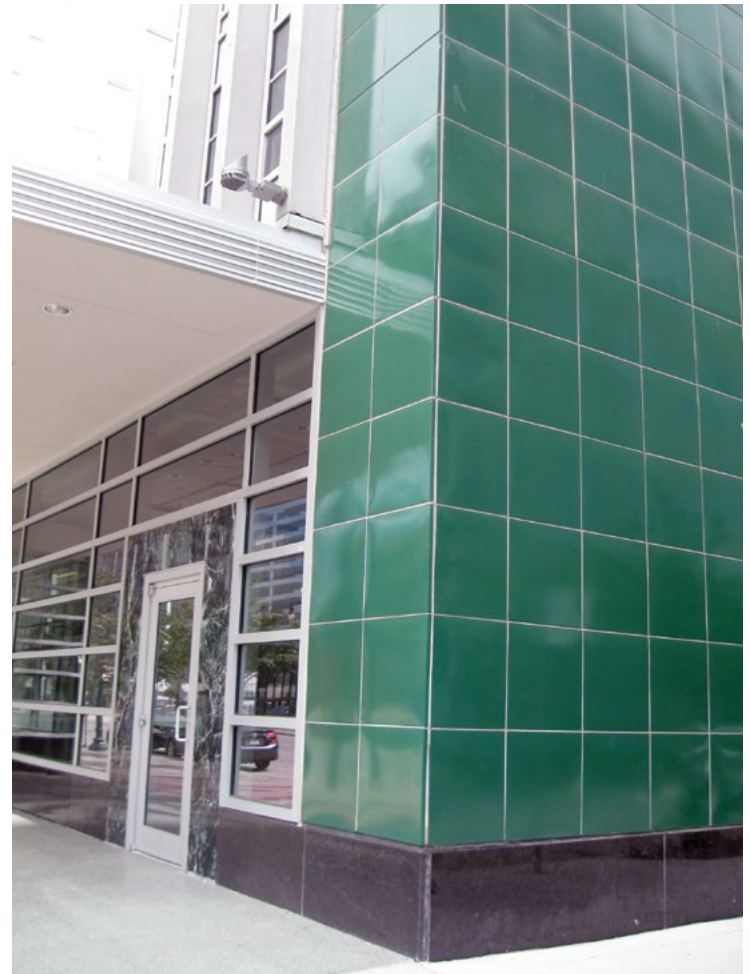
[15] New enameled-metal panels were replicated to replace the original panels, which were too deteriorated to repair, when the storefront of this early 1950s building was recreated.

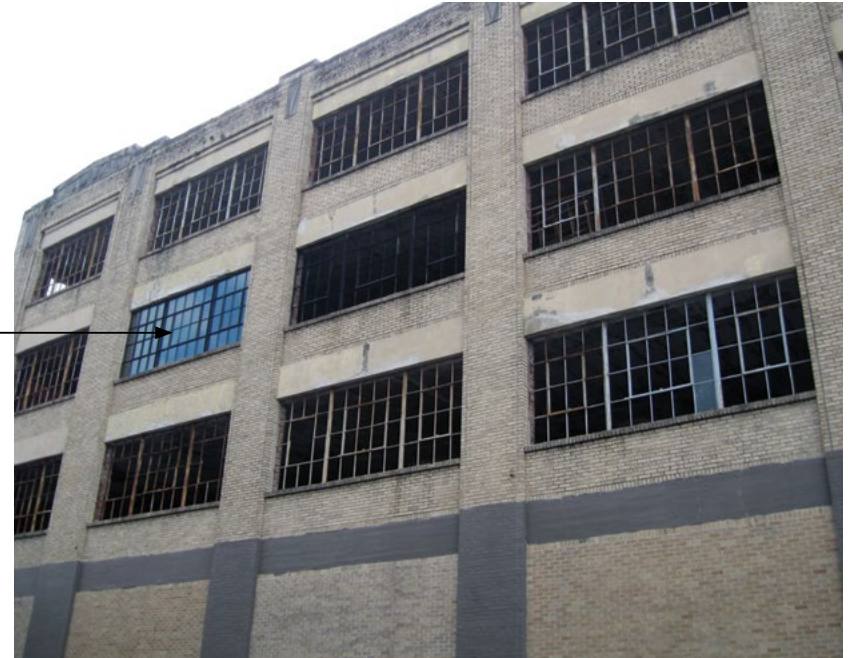
[19] Installing a mockup of a proposed replacement window can be helpful to evaluate how well the new windows will match the historic windows that are missing or too deteriorated to repair.
